# BELZONA REPAIRS STEAM TRAIN FOR UNDERGROUND ANNIVERSARY

ID: 5119

Customer Location: Locomotive repair workshop, Forest of Dean, UK

Application: ENC-Engines and Casings

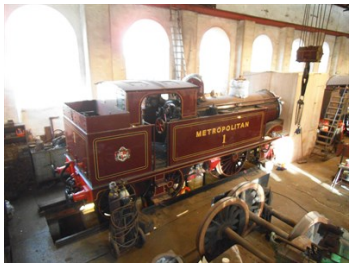
- \* Metropolitan number one shown with a heated application hut built around the front nose section ,
- \* Steam chest after grit blasting and application of Belzona 1511 under doubler plates bolted into place ,
- \* Belzona 1391 applied over the doubler plates ,
- \* Belzona 4181 applied as a final protection from foot traffic ,

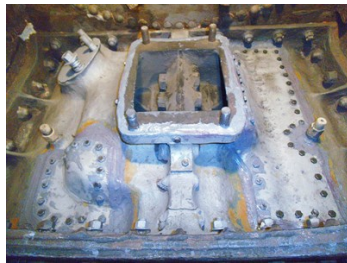
The steam chest (part of the main cylinder block on the train engine) had corroded and had several holes due to steam pressure and the corrosive chemicals wearing it away over many years. Without fixing these holes the engine would lose pressure and fail to run.

Application was carried out in accordance with Belzona Know-How System Leaflets ENC-1 and modified FPA-1. Doubler plates were

bonded in place with Belzona 1511 before being coated with Belzona 1391 to provide corrosion protection. Belzona 4181 was then applied to give additional corrosion resistance and resistance to foot traffic during maintenance work. The repair was then overlaid with fire clay to give an authentic appearance.
