# BELZONA REPAIRS STEAM TRAIN FOR UNDERGROUND ANNIVERSARY

Customer Location: Locomotive repair workshop, Forest of Dean, UK

Application: ENC-Engines and Casings

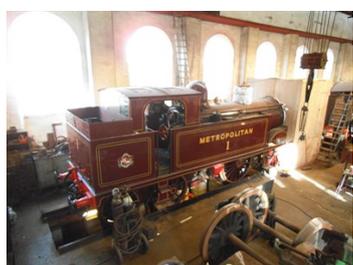
- \* Metropolitan number one shown with a heated application hut built around the front nose section ,
- \* Steam chest after grit blasting and application of Belzona 1511 under doubler plates bolted into place ,
- \* Belzona 1391 applied over the doubler plates ,
- \* Belzona 4181 applied as a final protection from foot traffic ,

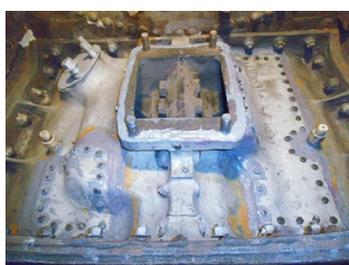
The steam chest (part of the main cylinder block on the train engine) had corroded and had several holes due to steam pressure and the corrosive chemicals wearing it away over many years. Without fixing these holes the engine would lose pressure and fail to run.

Application was carried out in accordance with Belzona Know-How System Leaflets ENC-1 and modified FPA-1. Doubler plates were

bonded in place with Belzona 1511 before being coated with Belzona 1391 to provide corrosion protection. Belzona 4181 was then applied to give additional corrosion resistance and resistance to foot traffic during maintenance work. The repair was then overlaid with fire clay to give an authentic appearance.
