# RUDDER REPAIR ON THE AIRCRAFT CARRIER «ADMIRAL GORSHKOV»

ID: 5155

Customer Location: Shipyard, Severodvinsk, Russia  
Application Date: November 2007

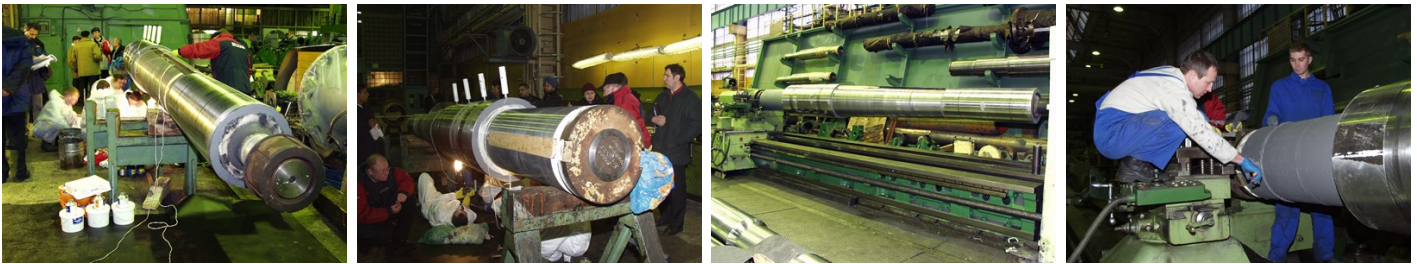
Due to corrosion wear of the rudder seat project 11430, performance and efficiency have considerably decreased

- \* Injecting Belzona 1321 to bond the steel surface of the rudder ,
- \* Sealing openings with Belzona 1111 ,
- \* Application of Belzona 1111 onto the rudder &ndash; cone shape rebuilding ,
- \* Repair completed ,

Repair was carried out according to Belzona Know-How System Leaflet SOS-3 that was approved by Russian Maritime Registry of Shipping
