# CONDENSER REPAIRED WITH BELZONA

**Customer Location:** Metallurgy Complex, Thermal Power Station, Vologda region, Russia

**Application:** HEX-Heat Exchangers

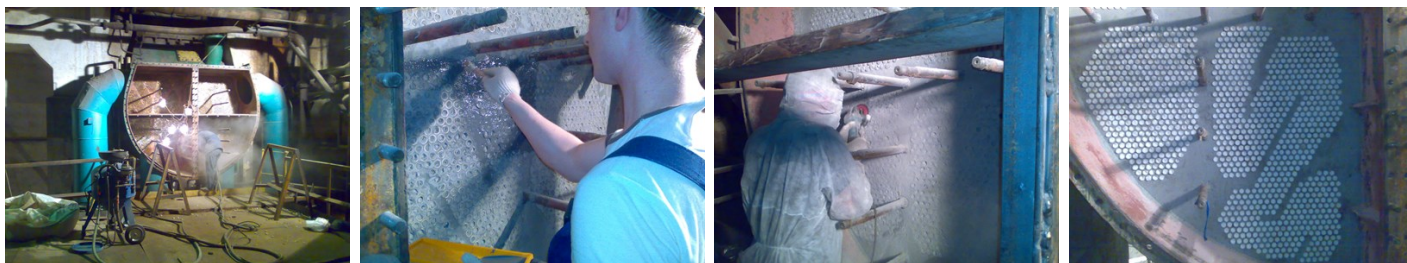
Machine was in service for a long time, which resulted in unacceptable tube sheet wear (thinning, in some places up to 5-7 mm from the original thickness of 40 mm)

- \* Grit blasting of the metal ,
- \* Corks placed in the holes, application of Belzona 1311 ,
- \* Machining of the finished application ,
- \* Application of Belzona 1321 ,

Deformation of the tube sheets due to bimetallic corrosion and erosion

The application was carried out in accordance to Belzona Know-How System Leaflet HEX-1. The repair was completed in 10 days by a team of 4 specialists
