PICKLE TANK REPAIRED USING BELZONA PLATE BONDING

ID: 5172

Customer Location: Automotive Parts Manufacturer, South Wales, UK

Application: TCC-Tanks and Chemical Containment Areas

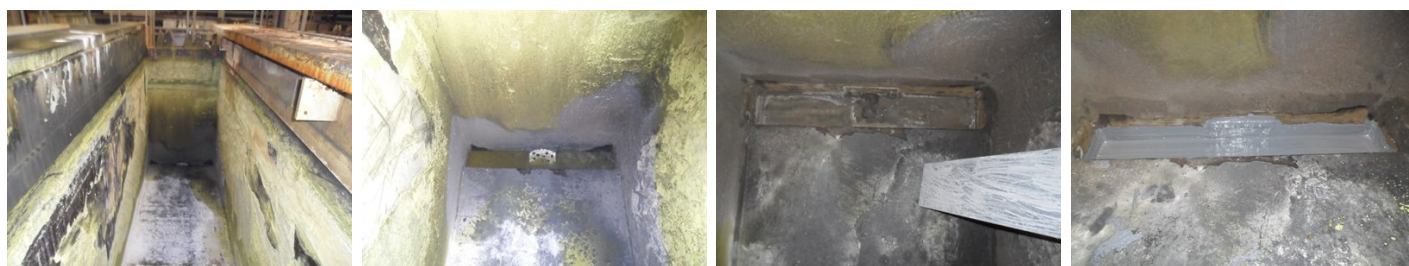
Photograph Descriptions

Corrosion issues prompted the Client to seek a cost effective solution to seal an internal-to-external drainage outlet. A swift application was required to eliminate any uncontrolled discharges of the acid to the internal working area.

- * Tank location ,
- * Pre-start ,
- * Area preparation & pre-coated plate ,
- * Application completed ,

The application was carried out in accordance with Belzona Know-How System Leaflet TCC-3. A mild steel plate, coated one side with Belzona 4311, was manufactured prior to attending site. The plate was bonded in place using Belzona 4301 and the edges sealed with further application of Belzona 4311.
