BELZONA REPAIRS SHAFT FOR FRENCH NAVY

ID: 5174

Motor shaft on the frigate "Jean de Vienne"

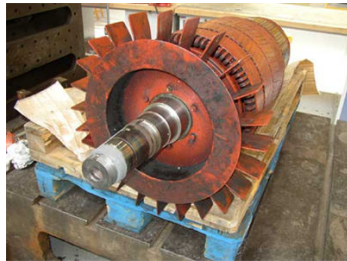
- * Frigate "Jean de Vienne" in drydock ,
- * Equipment with the damaged shaft ,
- * Close up of the damage on the shaft ,
- * Shaft after rebuilding with Belzona 1111 and machining ,

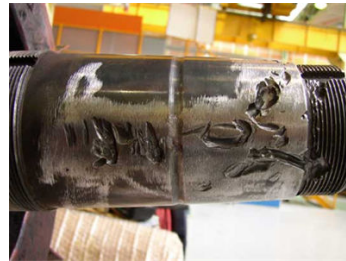
The tapered shaft had serious damage.

Application was carried out in accordance with Belzona Know-How System Leaflet MPT-1. The repair was machined to obtain a smooth finish.
