BELZONA WEATHERPROOFS TWO SUGAR SILOS

Industry: *Food & Drink*
 Application: *WPA-Wall Problem Areas*
 Substrate: *Concrete*
 Products: ** Belzona 3111 (Flexible Membrane),*

Customer Location: *Sugar factory, Northern France*
 Application Date: *2014*

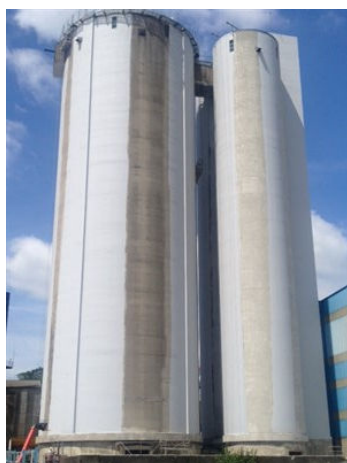
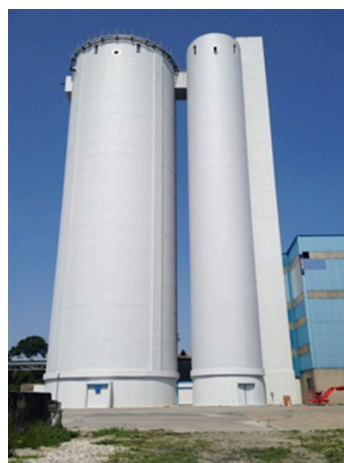
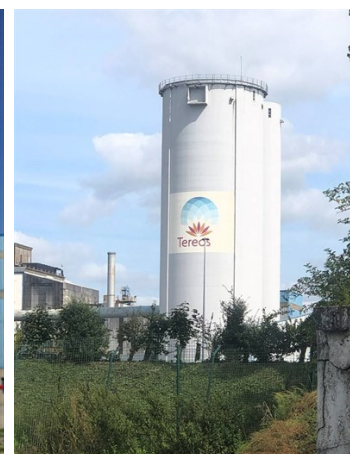
Infiltration of water into the tank through the porous concrete.

- * General view of the sugar plant ,
- * On-going application ,
- * Finished application ,
- * 6 years after the application ,

Two sugar silos within the sugar factory required weatherproofing

Application was carried out in accordance with Belzona System Leaflet WPA-1. The work was completed by applying the system in vertical stripes of 6 meter width.

The Belzona 3111 system is proven to provide excellent long term weatherproofing of substrates. The application was carried out in 10 weeks with a team of 7 applicators. The silos have been revisited after 2 years and 6 years later, the application was still in perfect condition.
