# BELZONA WEATHERPROOFS TWO SUGAR SILOS

ID: 5175

Customer Location: Sugar factory, Northern France  
 Application Date: 2014

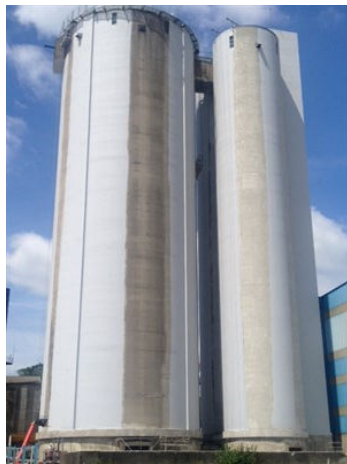
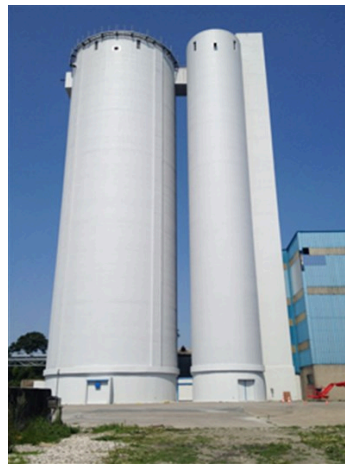
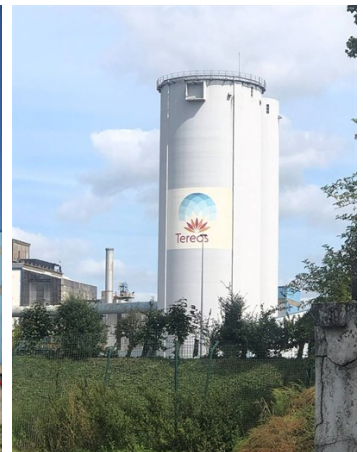
*Infiltration of water into the tank through the porous concrete.*

- \* General view of the sugar plant ,
- \* On-going application ,
- \* Finished application ,
- \* 6 years after the application ,

Application was carried out in accordance with Belzona System Leaflet WPA-1. The work was completed by applying the system in vertical stripes of 6 meter width.

The Belzona 3111 system is proven to provide excellent long term weatherproofing of substrates. The application was carried out in 10 weeks with a team of 7 applicators. The silos have been revisited after 2 years and 6 years later, the application was still in perfect condition.
