BELZONA REPAIRS DAMAGED PIN BUSH HOUSING

ID: 5180

Industry: *Mining & Quarrying*
Application: *MPT-Mechanical Power Transmission*

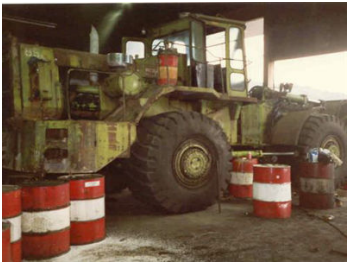
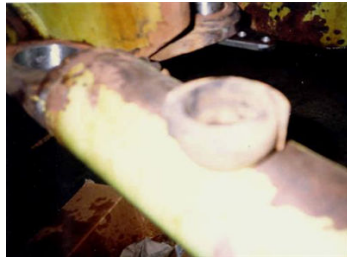
Bush housing holding articulating hydraulic arm would wear constantly requiring welding and line boring. Construction of bearing also presented a problem when inserting into housing. Because of the tight tolerances it would easily deform.

- * View of Terrex HD Equipment ,
- * Preparation of worn bush housing in progress ,
- * New pin bush and bearings coated with release agent ,
- * Completed application ,

Wear on bush housing.

Application carried out in accordance with Belzona Know-How System Leaflet MPT-8

Using Belzona eliminated the distortion problem ensuring that the bearing was not damaged during fitting. This ensured a longer life.
