# BELZONA REPAIRS DAMAGED PIN BUSH HOUSING

ID: 5180

Industry: *Mining & Quarrying*  
Application: *MPT-Mechanical Power Transmission*

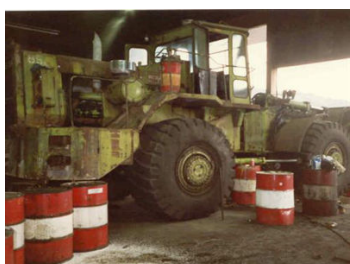
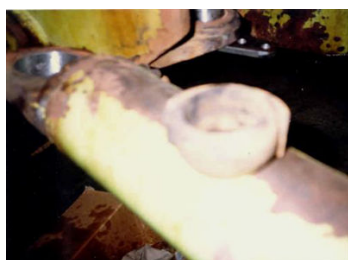
*Bush housing holding articulating hydraulic arm would wear constantly requiring welding and line boring. Construction of bearing also presented a problem when inserting into housing. Because of the tight tolerances it would easily deform.*

- \* View of Terrex HD Equipment ,
- \* Preparation of worn bush housing in progress ,
- \* New pin bush and bearings coated with release agent ,
- \* Completed application ,

Wear on bush housing.

Application carried out in accordance with Belzona Know-How System Leaflet MPT-8

Using Belzona eliminated the distortion problem ensuring that the bearing was not damaged during fitting. This ensured a longer life.
