# BELZONA REBUILDS SPLINE SHAFT

ID: 5182

Industry: *General Industry*  
Application: *MPT-Mechanical Power Transmission*

Substrate: *Steel*  
Products: *\* Belzona 1111 (Super Metal) ,*

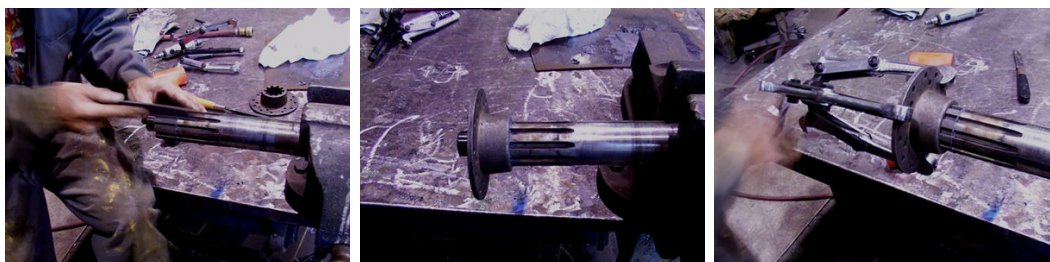
*Replacement part not readily available and purchasing the entire assembly would have been very costly.*

- \* Preparation of the damaged areas in progress ,
- \* Splines reformed with Belzona 1111 ,
- \* Mounting flange in the process of being removed revealing rebuilt splines. ,

Application carried out in accordance with Belzona Know-How System Leaflet MPT-5

The use of Belzona allowed localized repairs to be executed with a minimal amount of downtime.
