# BELZONA SHM-12 POSITIVE GRIP SYSTEMS USED TO RE-LAG DRIVE PULLEY

ID: 5188

Rubber lagging on drive pulley

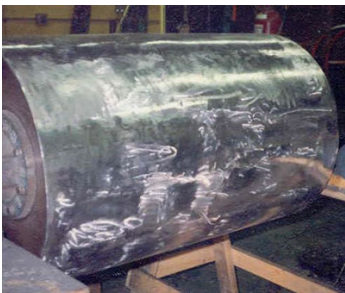
- \* The original lagging has been removed and the steel surface ground to provide a rough profile onto which the Belzona product is applied ,
- \* Completed application. In this instance a chevron type pattern was employed to ensure that rain water (Outside application) would be swept to the outer circumferences of the roll. ,

The original rubber lagging was no longer effective and customer opted for Belzona because it could be done in the maintenance shop over the weekend.

Application carried out in accordance with Belzona Know-How System Leaflet SHM-12

The Belzona product is applied directly to the steel roll. It also provides a far higher degree of positive traction increasing belt life by reducing slippage.
