BELZONA ELASTOMERS REPAIR CUT IN TIRE

ID: 5192

Industry: *Mining & Quarrying*
Application: *SHM-Solids Handling Machinery*

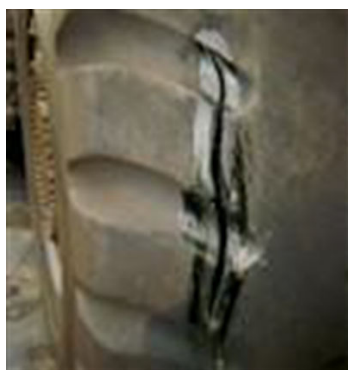
Tire on earthmoving equipment had been badly damaged.

- * View of equipment and the extent of the damaged area ,
- * Surface around the damaged area prepared and coated with Belzona 2911 ,
- * Damaged area sealed and rebuilt with Belzona 2211 ,

The application was carried out in accordance with Belzona Know-How System Leaflet SHM-1.

Quick repairs to this issue prevented further damage to the underlying reinforcing plies, allowing the equipment to continue operating until a scheduled downtime. Belzona 2311 cures rapidly, reaching full mechanical strength in about 2 hours.
