# BELZONA REBUILDS WORN CAT D9 SPLINESHAFT ASSEMBLY

ID: 5194

Industry: *Mining & Quarrying*  
Application: *MPT-Mechanical Power Transmission*

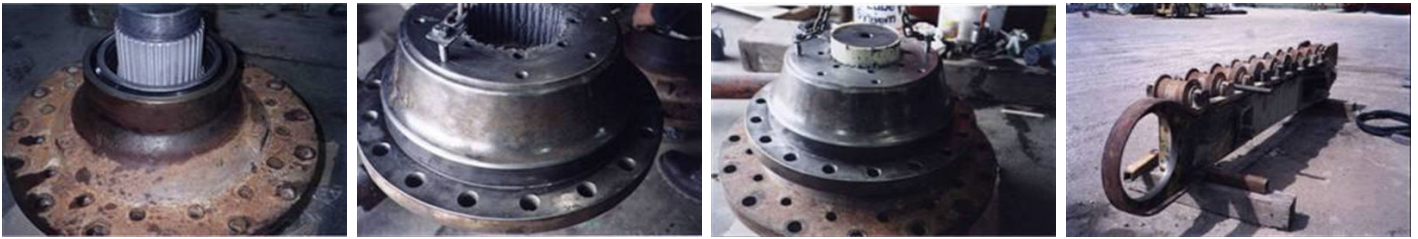
*The main drive spline on D-9 cat had worn loose over many years of service.*

- \* View of worn spline shaft assembly ,
- \* Belzona 1111 Super Metal applied to worn splines ,
- \* Components reassembled ,
- \* The main framework that the Spline assembly is being bolted to ,

Application carried out in accordance with a modified version of Belzona Know-How System Leaflet MPT-5
