# BELZONA EXTENDS THE LIFE OF DAMAGED TIRE

ID: 5196

Industry: Mining & Quarrying  
Application: SHM-Solids Handling Machinery

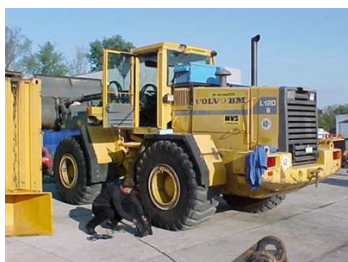
*The side wall of a tire, close to the rim, had been cut by a stray piece of metal*

- \* Vehicle with damaged tire ,
- \* Initial preparation underway with the removal of any loose material ,
- \* The surface around the damaged area is prepared with a special roughing tool ,
- \* Completed application. ,

Application carried out in accordance with a modified version of Belzona Know-How System Leaflet SHM-1. Surface around damaged area cleaned of loose road debris and roughen with a steel wire brush. Belzona 2911 (Elastomer QD Conditioner) was applied prior to Belzona 2211 to ensure proper adhesion.
