# BELZONA 1811 CERAMIC CARBIDE EXTENDS LIFE OF PUMP CASING

ID: 5198

Industry: Mining & Quarrying  
Application: CEP-Centrifugal Pumps  
Substrate: Stainless steel  
Products: \* Belzona 1811 (Ceramic Carbide) ,

Customer Location: BC, Canada  
Application Date: June 2000

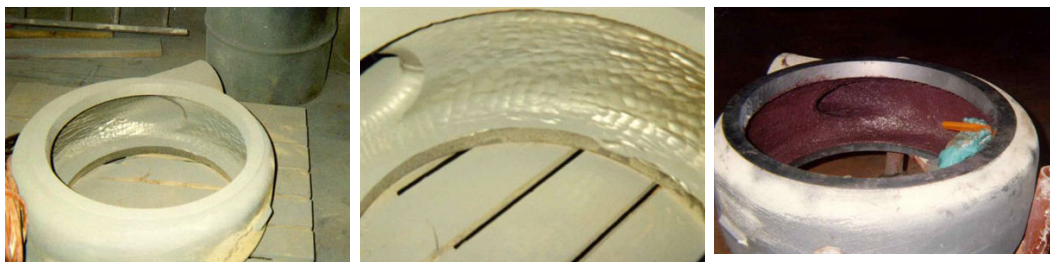
## Photograph Descriptions

*Pumping drainage water from a gravel pit has a high percentage of entrained solids causing major erosion damage to pumps*

- \* View of Pump ,
- \* Close-up of pump showing extent of erosion ,
- \* The internal surfaces of the pump casing are protected with Belzona 1811 ,

Erosion on gravel slurry pump

Application carried out in accordance with a modified version of Belzona Know-How System Leaflet CEP-1

Coating the internal surfaces with a sacrificial coating such as Belzona 1811 ensures that the pump casing can be recycled many times over
