# BELZONA REBUILDS ERODED METAL AND DAMAGED LINER

ID: 5201

Lining repair of a sand and gravel hopper

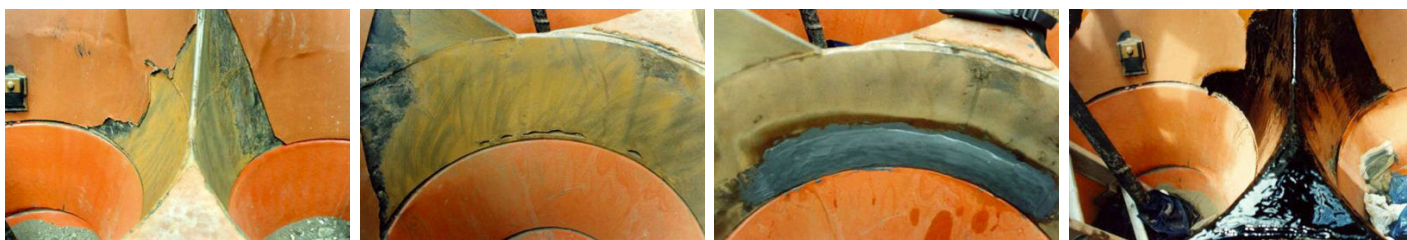
*The abrasion resistant lining of the hoppers had been damaged allowing corrosion to develop underneath it*

- \* Sand and Gravel Hopper ,
- \* View of the damaged liner ,
- \* Damaged liner stripped from the affected areas ,
- \* After preparing the metal surfaces the eroded area was rebuilt with Belzona 1311 ,

Application carried out in accordance with Belzona Know-How System Leaflet SHM-1

The use of Belzona products allowed for an onsite repair ensuring that the problem would not get any bigger.
