# BELZONA 1111 SUPER METAL SOLVES PROBLEM QUICKLY

Industry: *Mining & Quarrying*  
Application: *SHM-Solids Handling Machinery*

Substrate: *Steel*  
Products: *\* Belzona 1111 (Super Metal) ,*

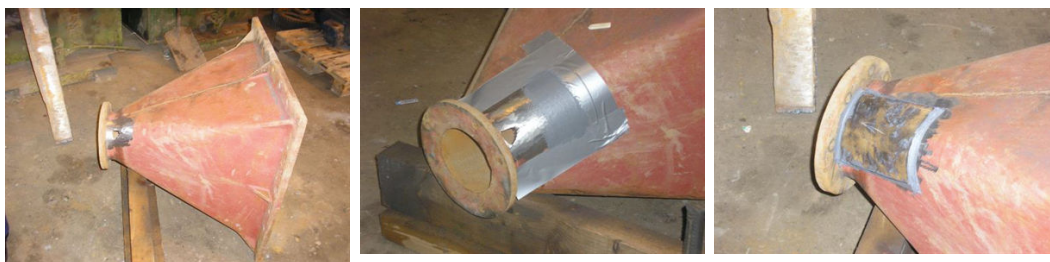
*Due to the continuous flow of abrasive aggregate and vibration the transition piece would wear out and crack.*

- \* The area to be repaired was ground to a clean rough surface with a mechanical grinder ,
- \* Repair in progress ,
- \* Completed repair. ,

Cracked hopper

Application carried out in accordance with a modified version of Belzona Know-How System Leaflet SHM-8

The use of Belzona to bond a patch over this problematical section proved to be quicker and easier to do than welding. The repair also lasted well beyond the standard welded repair.
