# BELZONA EXTENDS LIFE OF JET VALVE

ID: 5205

Application: *CEP-Centrifugal Pumps*

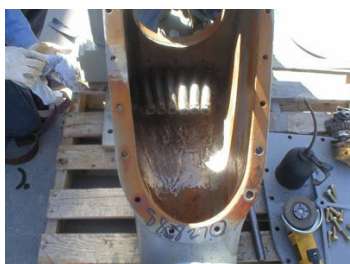
- \* View of the volute area ,
- \* Showing preparation in progress of the eroded area ,
- \* Application of the Belzona material in progress ,
- \* Application of the Belzona 1812 in progress ,
