# BELZONA REPAIRS BEARING SADDLE SUPPORT

ID: 5209

Bearing saddle support.

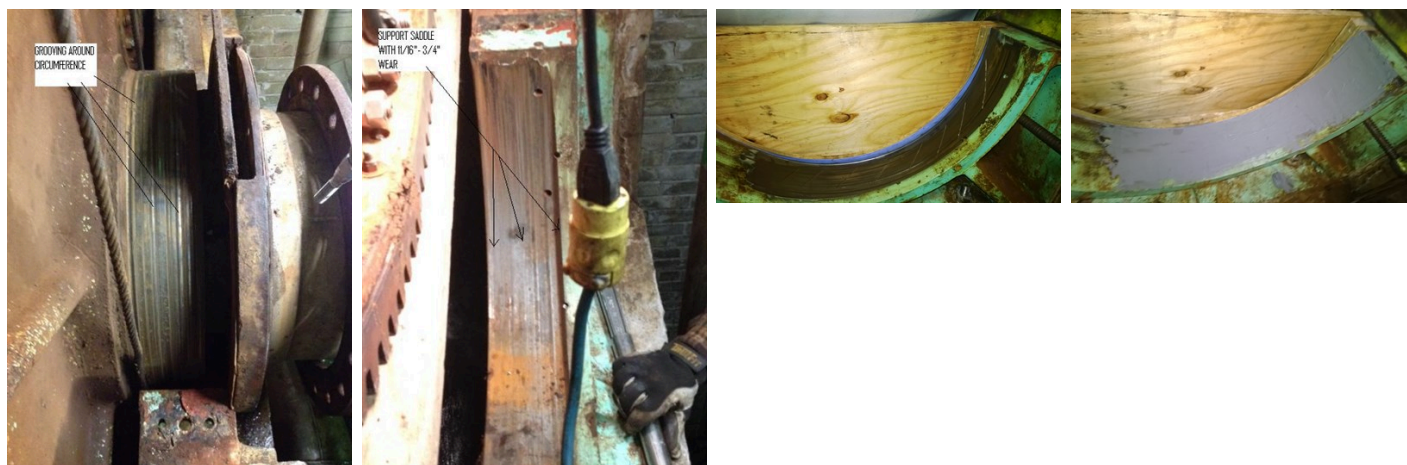
Severe metal loss from entrained solids in flowing water. During inspection, it was noted that a water screen bearing was grooved from abrasion. Upon removal for repair with Belzona 1111, it was further found that the support saddle was severely worn (3/4" +/-) under the bearing itself.

- \* Grooved bearing surface ,
- \* Support saddle showing deep grooves ,
- \* Plywood & gasket former ,
- \* Completed application ,

Hand tools, such as grinder, were used to prepare the surface. A plywood former was built to provide the profile depth. The application was carried out in accordance with a modified version of Belzona Know-How System Leaflet ENC-3b.
