# BELZONA REPAIRS AND PROTECTS DAMAGED DRAINS

ID: 5212

Customer Location: ON, Canada  
Application Date: June 2013

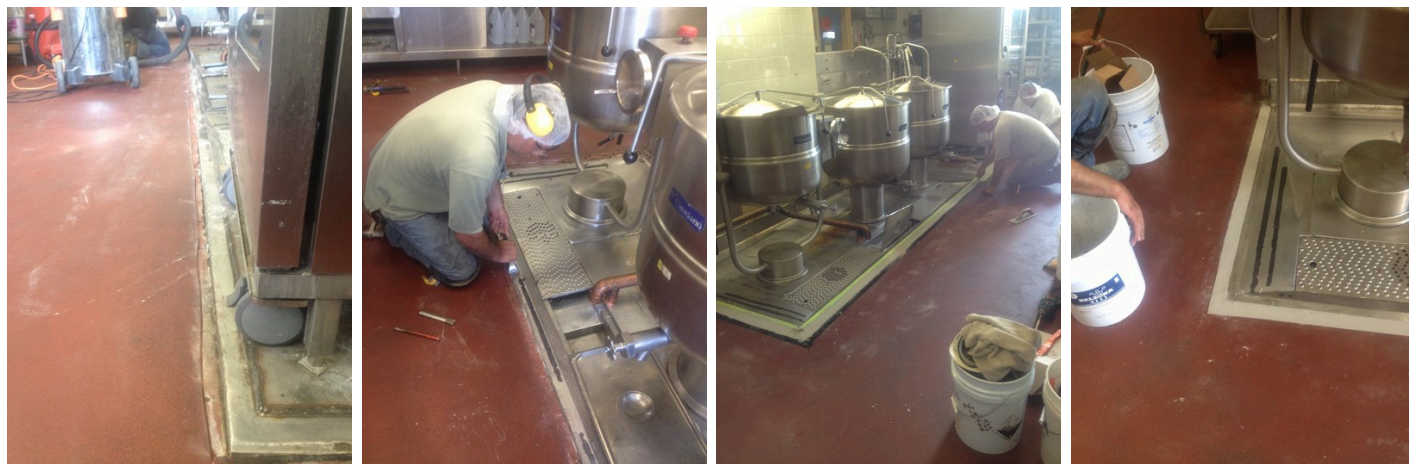
*The edges of the floor drain were breaking due to a combination of chemical attack and physical damage.*

- \* Floor drain prior to application ,
- \* Preparation in process ,
- \* Application in process ,
- \* Completed application ,

The application was carried out in accordance with Belzona Know-How System Leaflet FPA-1 for rebuilding worn or damaged floor surfaces. The surface was prepared by removing any existing coating and loose material or contamination. Belzona 4111 was applied to the floor drain edges with a stiff brush, in accordance with Belzona's Instructions For Use.
