BELZONA REPAIRS AND PROTECTS DAMAGED DRAINS

ID: 5212

Industry: *General Industry*
Application: *FPA-Floor Problem Areas*
Substrate: *Concrete*
Products: ** Belzona 4111 (Magma-Quartz) ,*

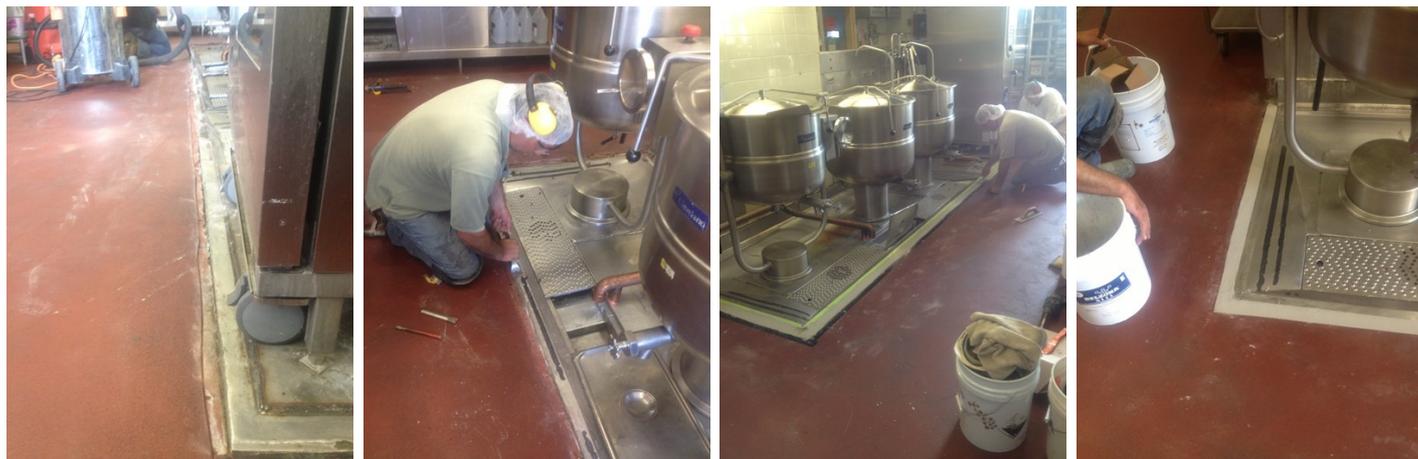
Photograph Descriptions

The edges of the floor drain were breaking due to a combination of chemical attack and physical damage.

- * Floor drain prior to application ,
- * Preparation in process ,
- * Application in process ,
- * Completed application ,

The application was carried out in accordance with Belzona Know-How System Leaflet FPA-1 for rebuilding worn or damaged floor surfaces. The surface was prepared by removing any existing coating and loose material or contamination. Belzona 4111 was applied to the floor drain edges with a stiff brush, in accordance with Belzona's Instructions For Use.
