# BELZONA SAVES THOUSANDS OF DOLLARS WITH HOUSING REPAIR

ID: 5215

Industry: *Transport*  
Application: *ENC-Engines and Casings*  
Substrate: *Steel*  
Products: *\* Belzona 1111 (Super Metal) ,*

Customer Location: *Cambridge, ON, Canada*  
Application Date: *August 2011*

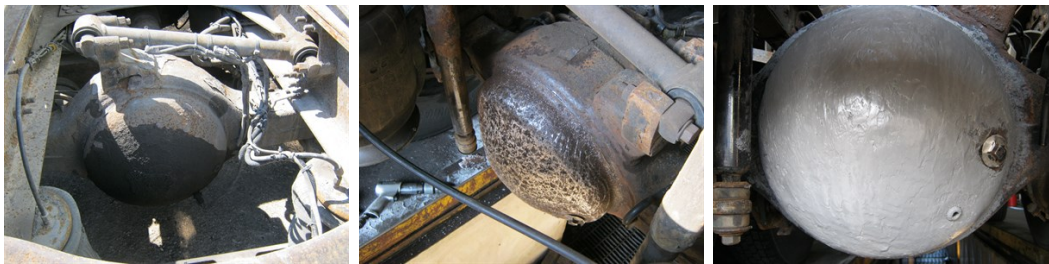
## Photograph Descriptions

*A large fleet of trucks were aging, which was causing severe corrosion of the rear differential housings and leaking oil.*

- \* Prior to application ,
- \* Preparation complete ,
- \* Complete application ,

Rear differential housings of a large fleet of trucks.

The application was carried out in accordance with Belzona Know-How System Leaflet ENC-6 for repairing erosion-corrosion damages. The surface was prepared by grinding the surface to roughen the application area. Belzona 1111 was applied until all pitted and eroded areas were completely filled and the housing was completely coated with Belzona 1111.
