BELZONA REDUCES DOWNTIME WITH SHAFT REPAIR

Industry: *General Industry*
Application: *FBC-Fans, Blowers and Compressors*

Bearing shaft.

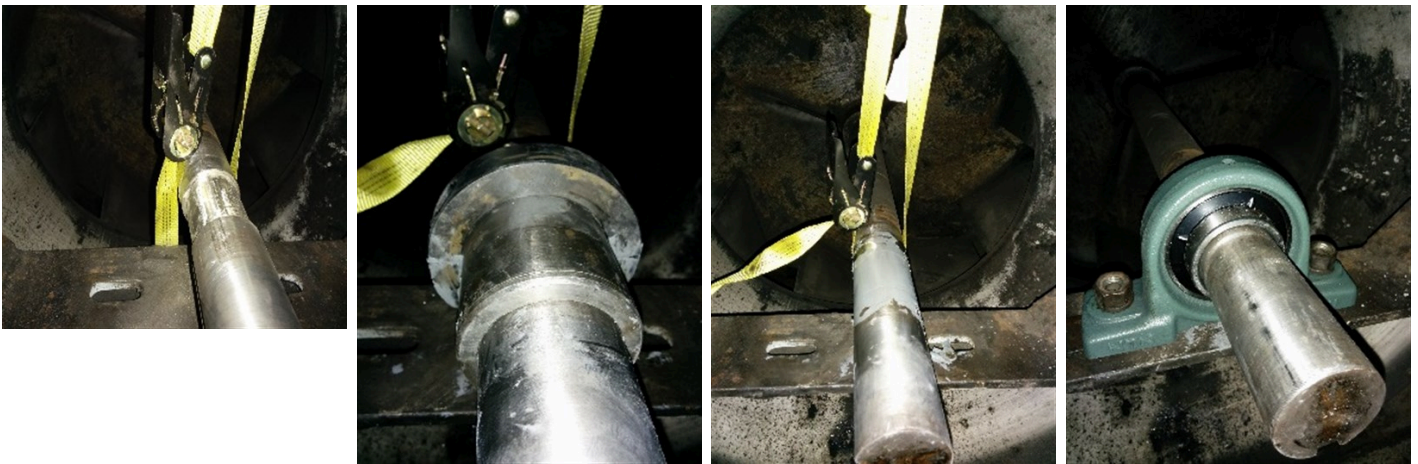
Photograph Descriptions

Bearing failure caused severe scoring to shaft.

- * Prior to application ,
- * Preparation in process ,
- * Completed application ,
- * Completed application in service ,

The application was carried out in accordance with Belzona Know-How System Leaflet FBC-13 for repairing shafts by forming techniques. The surface was prepared by mechanical grinding and cleaning with Belzona 9111 to remove all residue. The former's interior was prepared with Belzona 9411. Belzona 1111 was applied to the shaft and former, and the former was installed on the

shaft. After curing, the former was removed and the shaft was checked for fit tolerance.
