BELZONA REPAIRS TUBE SHEETS OF A HEAT EXCHANGER

ID: 5220

Industry: Heating, Ventilation & Air Conditioning
Application: HEX-Heat Exchangers
Substrate: Stainless steel and Titanium
Products: * Belzona 1311 (Ceramic R-Metal) ,
* Belzona 1321 (Ceramic S-Metal) ,

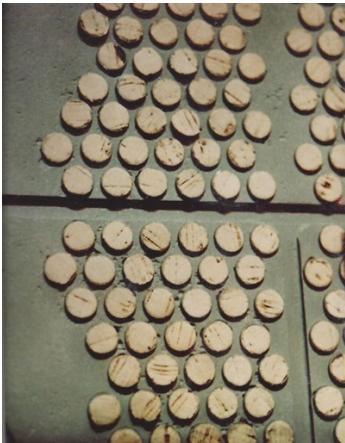
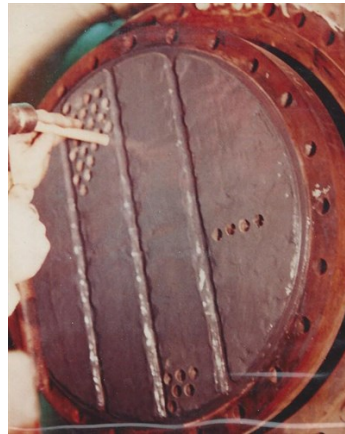
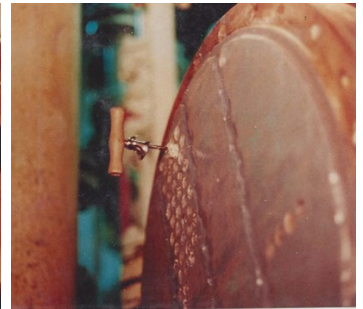
Photograph Descriptions

One year old tube sheets were already leaking around the tubes. Electrolysis has eaten away much of the tube sheet and plate.

- * Tube sheet with corks inserted ,
- * Applying Belzona 1311, then two coats of Belzona 1321 ,
- * Breaking corks loose with wood dowel ,
- * Pulling corks with a cork screw ,

The application was carried out in accordance with Belzona Know-How System Leaflet HEX-1.

all ten of the heat exchangers were rebuilt in seven days using only \$15,000.00, saving time and money.
