BELZONA REPAIRS TUBE SHEETS OF A HEAT EXCHANGER

ID: 5220

Application: HEX-Heat Exchangers

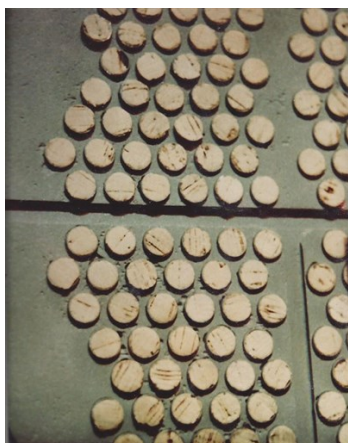
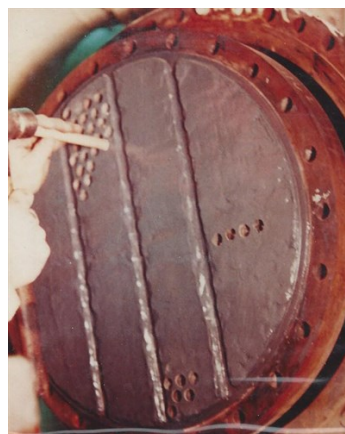
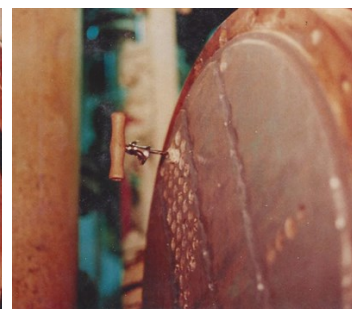
Photograph Descriptions

One year old tube sheets were already leaking around the tubes. Electrolysis has eaten away much of the tube sheet and plate.

- * Tube sheet with corks inserted ,
- * Applying Belzona 1311, then two coats of Belzona 1321 ,
- * Breaking corks loose with wood dowel ,
- * Pulling corks with a cork screw ,

The application was carried out in accordance with Belzona Know-How System Leaflet HEX-1.

all ten of the heat exchangers were rebuilt in seven days using only \$15,000.00, saving time and money.
