BELZONA SAVES CENTRIFUGAL PUMP FROM REPLACEMENT

ID: 5221

Industry: Food & Drink
Application: CEP-Centrifugal Pumps
Substrate: Cast Iron
Products: * Belzona 1341 (Supermetalgilde) ,

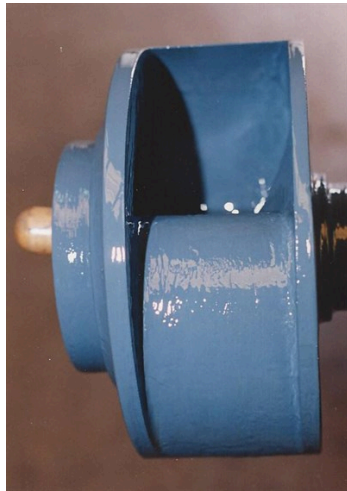
Erosion/Corrosion was eating away this water pump at a fruit processing company, causing it to pump less water than was required. It was then pulled from the scrap pile.

- * Damaged Cornell pump ,
- * Coating of impeller ,
- * Coating of pump casing ,

The application was carried out in accordance with Belzona Know-How System Leaflet CEP-10. The centrifugal pump was rebuilt to improve efficiency.

The customer was ready to replace the pump because it just wasn't pumping enough water. Belzona 1341 improved the volume, enough to satisfy their needs.
