BELZONA REPAIRS ROAD ROLLER'S SHAFT

ID: 5225

Industry: *Mining & Quarrying*
Application: *MPT-Mechanical Power Transmission*

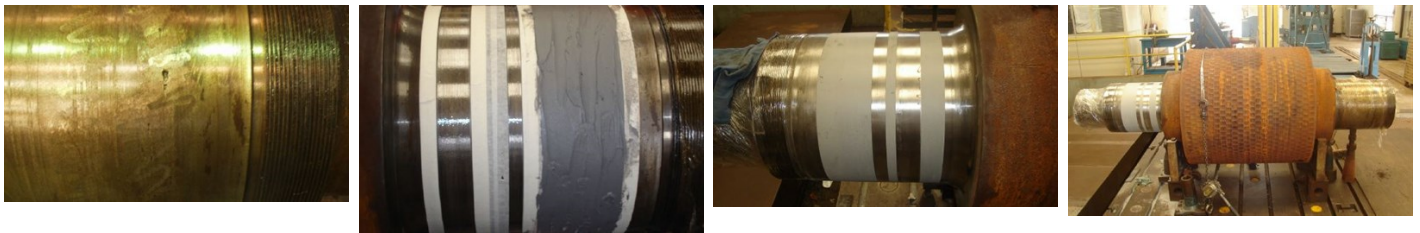
Photograph Descriptions

The shaft of a road roller presented wear with thickness loss at the bearing seat area, which was probably caused by occasional seizure. It was necessary to repair this area with a product that had excellent mechanical strength so that the part could return to normal operation. Operating conditions: Temperature < 93°C (immersion); 200°C (dry).

- * Worn shaft before the repair ,
- * Application of Belzona 1111 ,
- * Shaft after the repair and machining ,
- * General view of the equipment after repair and machining ,

Repair was carried out in accordance with Belzona Know How System Leaflet MPT-1. Surface preparation was obtained by machining, leaving the affected area with a coarse and rough thread profile. Afterwards, cleaning was carried out with a degreaser. Belzona 1111 was applied on the prepared area, and the excess was removed by machining, thus obtaining the required dimensions. Equipment dimensions: weight: approximately 8.5 tons. Diameter: 440 mm. Recovered width: 200 mm.
