BELZONA PROTECTS AND COATS PUMPS

ID: 5226

Industry: Power
Application: CEP-Centrifugal Pumps
Substrate: Steel and cast iron
Products: * Belzona 1311 (Ceramic R-Metal) ,
* Belzona 1341 (Supermetalgilde) ,

Customer Location: MO, USA
Application Date: March 2011

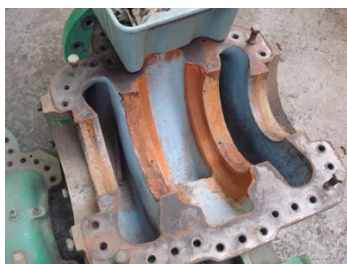
The customer wanted to re-coat the pump although it showed very little sign of wear.

- * View of the Energy Company ,
- * Previous application by Belzona ,
- * Preparing the product for application ,
- * Completed application ,

During a scheduled maintenance outage, the customer wanted a pump that was previously protected with Belzona to be remediated while it was out for inspection. Note: this pump was still performing as expected.

All of the equipment receiving the Belzona coating was grit blasted with Black Beauty and then cleaned. Any severe pitting and erosion was addressed by rebuilding with Belzona 1311 and finished with two coats of Belzona 1341, the known pump-efficiency enhancement system. The application was carried out in accordance with Belzona Know-How System Leaflets CEP-3 & CEP-5.
