BELZONA REPAIRS HIGH VOLTAGE BREAKER

ID: 5233

Industry: Power

SF6 High Voltage Breaker.

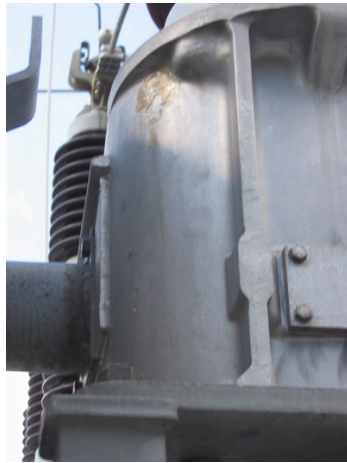
The aluminum casting on a SF6 High Voltage Breaker cracked, causing coolant to leak out and create a dangerous operating situation. Dismounting and replacing the breaker was not an option as no spare breaker was available for months.

- * Overview of the converter station ,
- * The leaking area ,
- * Completed surface preparation ,
- * Completed application ,
