BELZONA REPAIRS HIGH VOLTAGE BREAKER

ID: 5233

SF6 High Voltage Breaker.

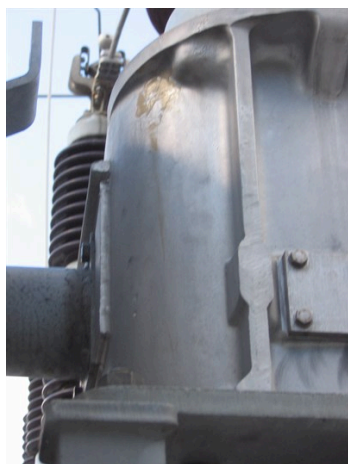
The aluminum casting on a SF6 High Voltage Breaker cracked, causing coolant to leak out and create a dangerous operating situation. Dismounting and replacing the breaker was not an option as no spare breaker was available for months.

- * Overview of the converter station ,
- * The leaking area ,
- * Completed surface preparation ,
- * Completed application ,
