# Abrasion Control on Steel Bent Elbow Pipes with Belzona

ID: 5236

Customer Location: Mill, South Carolina  
Application Date: September 2011

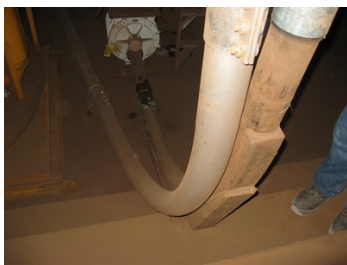
Original steel pipes are built with a 2"x4" steel base that supports the bottom of the bent steel pipe. Heavy abrasion discharge from dust and mill operation particles penetrate the cylindrical steel wall surface and erode the base requiring pipe replacement or extensive welding.

- \* Steel bent discharge pipe in operation ,
- \* Bent dust discharge pipe pre-drilled hole portal ,
- \* Bent dust discharge pipe filled with Belzona 1391 ,
- \* Bent discharge pipe plugged prior to cure of 1391 ,
