Abrasion Control on Steel Bent Elbow Pipes with Belzona

ID: 5236

Customer Location: *Mill, South Carolina*
Application Date: *September 2011*

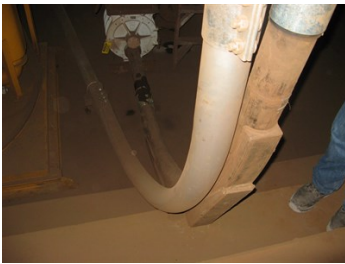
Original steel pipes are built with a 2"x4" steel base that supports the bottom of the bent steel pipe. Heavy abrasion discharge from dust and mill operation particles penetrate the cylindrical steel wall surface and erode the base requiring pipe replacement or extensive welding.

- * Steel bent discharge pipe in operation ,
- * Bent dust discharge pipe pre-drilled hole portal ,
- * Bent dust discharge pipe filled with Belzona 1391 ,
- * Bent discharge pipe plugged prior to cure of 1391 ,
