# BELZONA PROTECTS CONCRETE CONTAINMENT BASIN

**Industry:** Chemical & Petrochemical  
**Application:** TCC-Tanks and Chemical Containment Areas  
**Substrate:** Newly poured concrete  
**Products:** \* Belzona 4311 (Magma CR-1) ,  
\* Belzona 4181 (AHR Magma Quartz) ,  
\* Belzona 4911 (Magma TX Conditioner) ,

**Customer Location:** Orangeburg, South Carolina  
**Application Date:** November 2011

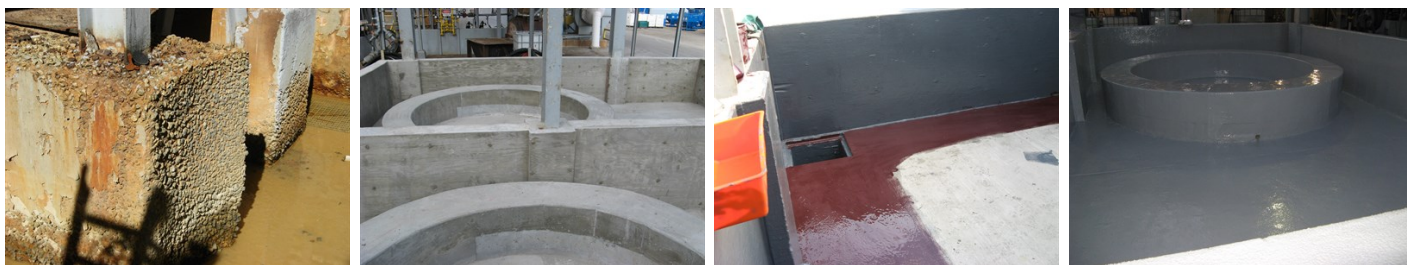
Agressive chemicals, aluminum chloride, aluminum chlorhydrate, ferric acid and hydrogen chloride destroyed the concrete after many years of service at this plant. The tank foundation support, walls, floors and drain bunds need protection from these chemicals.

- \* Column support uncoated and exposed to chemical penetration and erosion. ,
- \* Newly poured concrete containment area. ,
- \* Concrete tank support area with 4311 applied. ,
- \* Completed containment area after 2 coats. ,

Belzona Know-How System Leaflets TCC-15 and FPA-3 with some modification were followed. Concrete was pre-powerwashed and allowed to dry according to the IFU time frame. Concrete was tested for moisture content. All materials were brushed or rolled on. Belzona 4311 was applied in two coats after curing and application of Belzona 4911 conditioner on the walls and floor. Belzona 4181 was applied into the bunds as this is where the greatest accumulation of chemicals will sit.
