BELZONA PROTECTS CONCRETE CONTAINMENT BASIN

ID: 5237

Industry: Chemical & Petrochemical
Application: TCC-Tanks and Chemical Containment Areas

Customer Location: Orangeburg, South Carolina
Application Date: November 2011

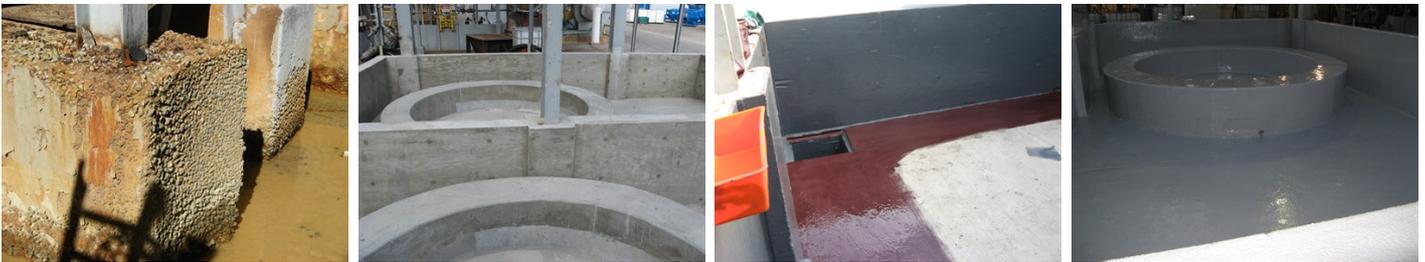
Photograph Descriptions

Agressive chemicals, aluminum chloride, aluminum chlorhydrate, ferric acid and hydrogen chloride destroyed the concrete after many years of service at this plant. The tank foundation support, walls, floors and drain bunds need protection from these chemicals.

- * Column support uncoated and exposed to chemical penetration and erosion. ,
- * Newly poured concrete containment area. ,
- * Concrete tank support area with 4311 applied. ,
- * Completed containment area after 2 coats. ,

Belzona Know-How System Leaflets TCC-15 and FPA-3 with some modification were followed. Concrete was pre-powerwashed and allowed to dry according to the IFU time frame. Concrete was tested for moisture content. All materials were brushed or rolled on. Belzona 4311 was applied in two coats after curing and application of Belzona 4911 conditioner on the walls and floor. Belzona 4181 was applied into the bunds as this is where the greatest accumulation of chemicals will sit.
