BELZONA REPAIRS SUMP AT A GAS STATION

ID: 5239

Sump at a gas station.

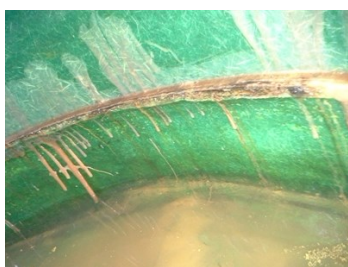
Water was flowing in through the seams inside the sump.

- * Prior to application ,
- * Application in progress ,
- * Completed application ,
- * Completed application ,

The application was carried out in accordance with Belzona Know-How System Leaflet TCC-1 for sealing cracks, porous welds, bolted and riveted joints. The area was prepared by roughing the surface. Belzona 1291 was applied by forcing the mixed material into the cracks and holes and Belzona 9341 was applied. Belzona 1161 was applied to the seam of the sump.
