BELZONA REPAIRS SUMP AT A GAS STATION

ID: 5239

Customer Location: *St. Thomas, ON, Canada*
Application Date: *July 2014*

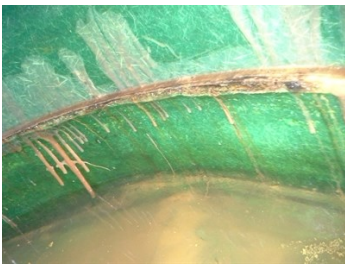
Water was flowing in through the seams inside the sump.

- * Prior to application ,
- * Application in progress ,
- * Completed application ,
- * Completed application ,

The application was carried out in accordance with Belzona Know-How System Leaflet TCC-1 for sealing cracks, porous welds, bolted and riveted joints. The area was prepared by roughing the surface. Belzona 1291 was applied by forcing the mixed material into the cracks and holes and Belzona 9341 was applied. Belzona 1161 was applied to the seam of the sump.
