BELZONA PROTECTS PARAPET WALLS FROM WATER PENETRATION

ID: 5240

Industry: *Buildings & Structures*
Application: *RPA-Roof Problem Areas*
Substrate: *Concrete*
Products: ** Belzona 3911 (PSC Surface Conditioner) ,*
** Belzona 5131 (EG-Cladding) ,*

Customer Location: *Toronto, ON, Canada*
Application Date: *August 2013*

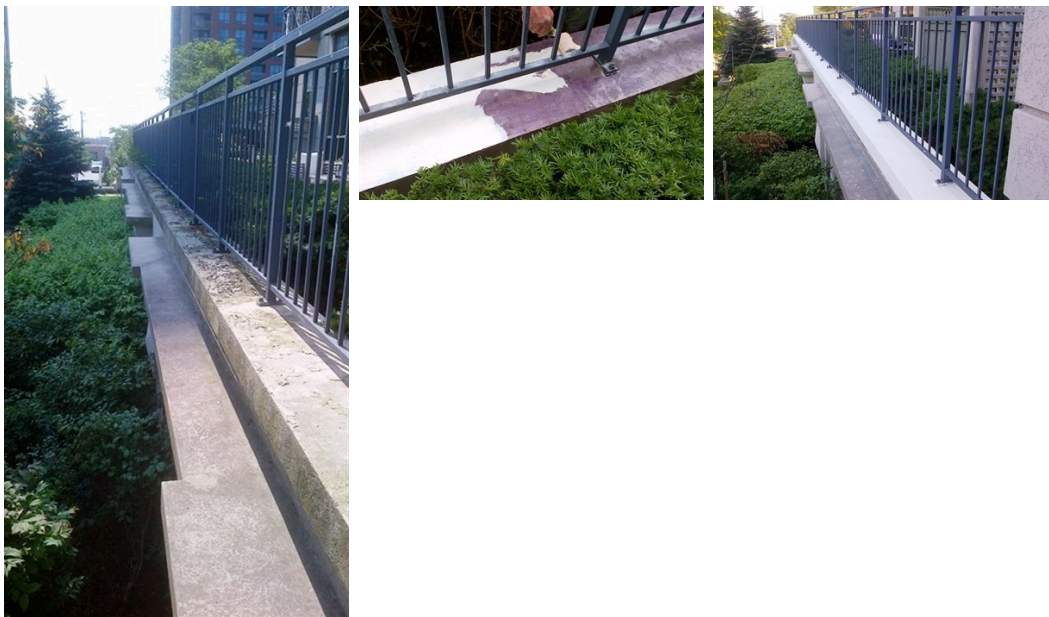
Photograph Descriptions

Water was penetrating the concrete.

- * Prior to application ,
- * Application in progress ,
- * Completed application ,

Parapet walls of a condominium building.

The application was carried out in accordance with Belzona Know-How System Leaflet RPA-10 for sealing leaking areas in parapet walls and copings. A wire brush was used to prepare the surface and brushed off to remove all the dust. Belzona 3911 was applied

with a brush to the entire surface. Belzona 5131 was applied with a lambs wool roller in accordance with Belzona Instructions For Use.
