BELZONA RETURNS CONVEYOR BELT TO SERVICE

ID: 5244

Industry: General Industry
Application: SHM-Solids Handling Machinery

Customer Location: Ajax, ON, Canada
Application Date: June 2012

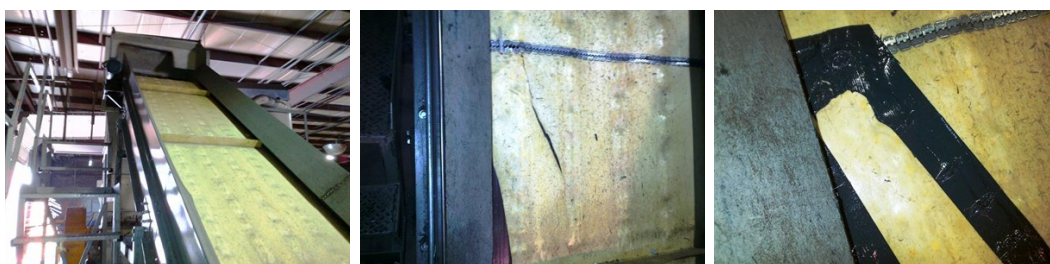
Photograph Descriptions

The conveyor belt had torn and was taken offline until it was repaired.

- * Conveyor belt ,
- * Prior to application ,
- * Completed application ,

The application was carried out in accordance with Belzona Know-How System Leaflet SHM-1 for repairing ripped, torn and worn conveyor belts. The surface was prepared by removing any worn fabric or torn rubber and using a rotary wire brush to abrade the surface, producing a wooly surface. Belzona 9111 was used to clean the entire area. Belzona 2911 was applied to the prepared surface area and Belzona 2211 was brush applied to the surface area.
