BELZONA RESCUES CELL PHONE ANTENNAS

ID: 5246

Customer Location: Deer Park, WA, USA
Application Date: June 2014

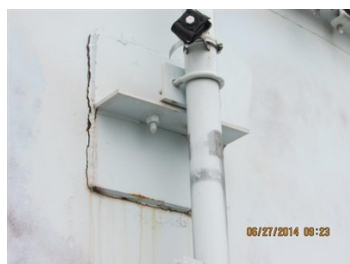
A series of steel plates with expensive cell phone antennas mounted to them on this water tower were found to be failing. The previous product had dis-bonded and they were no longer attached to the water tower.

- * 1. Failing plate in place ,
- * 2. Failed plate ,
- * 3. Application complete ,
- * 4. View from the ground ,

Previous material was removed, the surface of the plates were ground clean, and then roughened as well as the sides. The four sides of the plate were also chamfered to produce an additional mechanical bond once the Belzona 1111 had cured. The steel surface of the water tower was also ground to remove the previous material and then prepared with the MBX Bristle Blaster. Belzona 1111 was then mixed, and applied and the plate was remounted in it's original position.
