# Belzona Reduces Downtime for Concrete Bridge Expansion Joint Repairs

Customer Location: *Department of Transportation - Texas  
USA*

Application: *FPA-Floor Problem Areas*

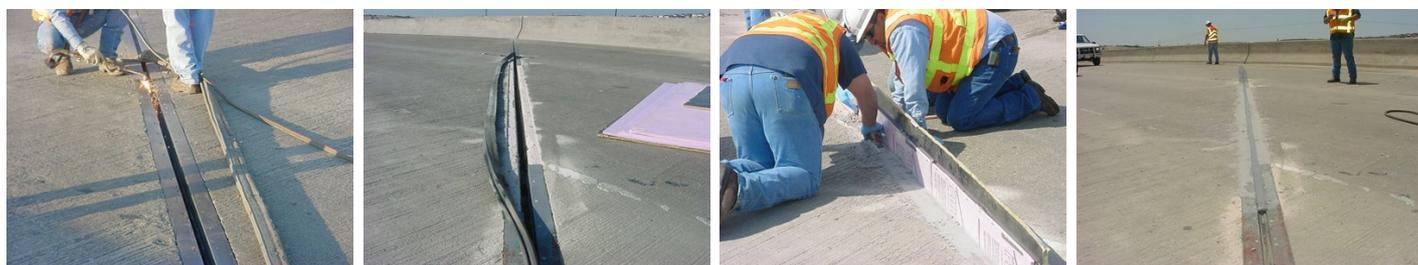
*Loose, dangerous expansion joint. Client needed a way to restore the joint edges and seal the joint while minimizing traffic disruption.*

- \* Steel armor being cut off. ,
- \* Concrete edges blasted. Old rubber seal will be used as backer rod for Belzona® 4521. ,
- \* Belzona® 4111 being troweled and packed. ,
- \* Completed repair. ,

Application was carried out in accordance with modified versions of Belzona Know-How System Leaflets FPA-5 and FPA-6.

The Belzona® 4111/Belzona® 4521 combination allows this type of repair to be made much faster and at a lower cost than conventional concrete repair procedure. Traffic disruption time is reduced. Past repairs using concrete involved removing old joint, jack hammer out old concrete, repour and then come back at a latter date to seal the joint. The Belzona system eliminates the return trip.
