# BELZONA SAVES TIME AND REDUCES COSTS WITH BUSHING REPAIR

ID: 5256

Loader arm bush housing.

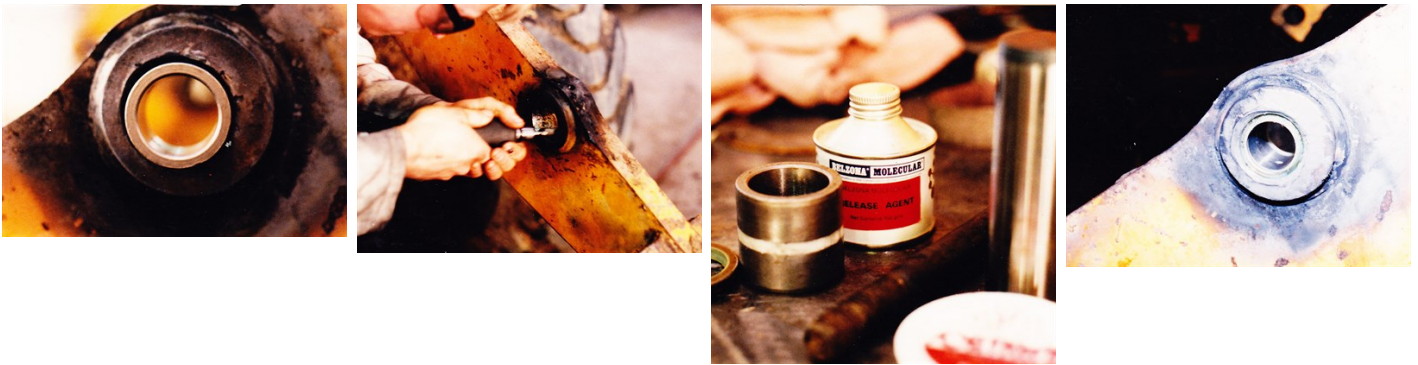
*The loader arm bush housing was worn oversize. Welding and boring would require removing the arm.*

- \* Loader arms showing wear ,
- \* Grinding the housing ,
- \* Belzona 9411 on new bushing, grease groove full of wax ,
- \* New bushing in place ,

The application was carried out in accordance with Belzona Know-How System Leaflet MPT-7. The new bushing had a grease groove around the outside. Candle wax was melted to fill the groove. After Belzona 1111 cured, a torch was used to melt the wax and a grease gun pumped in grease, pushing the melted wax out.
