# BELZONA REPAIRS ENGINE CASING

ID: 5260

Industry: *General Industry*  
Application: *ENC-Engines and Casings*  
Substrate: *Cast Iron*  
Products: *\* Belzona 1111 (Super Metal) ,*

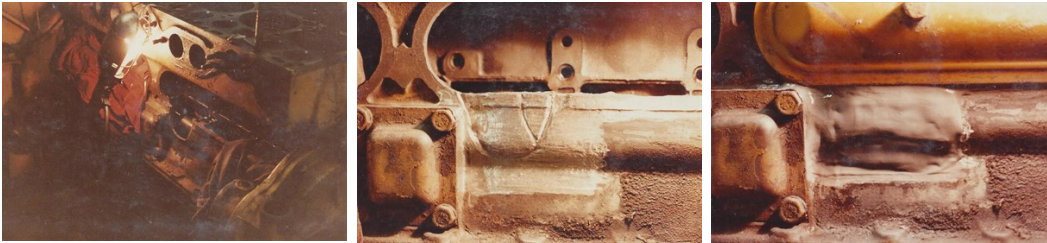
*The engine block had a large piece of the casing broken off.*

- \* Engine block showing missing pieces ,
- \* Two pieces locked in place with studs ,
- \* Completed application with Belzona 1111 ,

The application was carried out in accordance with Belzona Know-How System Leaflet ENC-1. After the proper surface preparation, the two broken pieces were locked in place using studs and Belzona 1111 was applied.

Twenty dollars worth of Belzona 1111 saved the engine block from being scrapped. The customer was fully satisfied with the results.
