# BELZONA SAVES DRAIN DAMAGED BY CHEMICALS

Industry: *Food & Drink*  
Application: *FPA-Floor Problem Areas*  
Substrate: *Concrete and Steel*  
Products: *\* Belzona 4111 (Magma-Quartz) ,*  
*\* Belzona 4311 (Magma CR1) ,*  
*\* ,*

Customer Location: *Washington, USA*  
Application Date: *1993*

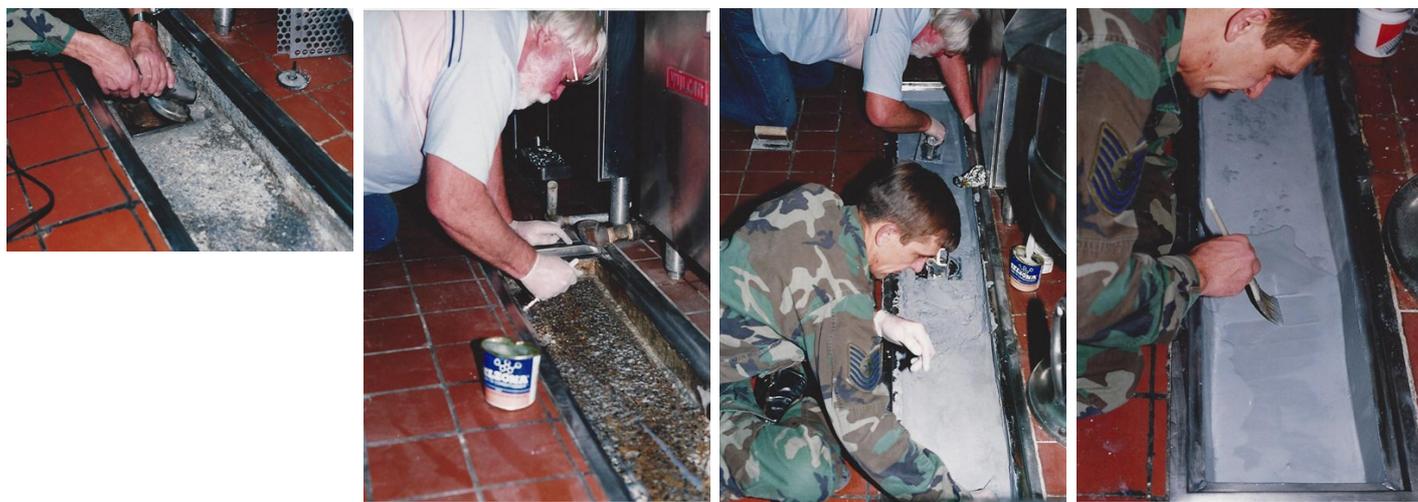
*Chemicals used to clean equipment in the kitchen were destroying the concrete in the drain.*

- \* Grinding the steel drain ,
- \* Conditioning the concrete ,
- \* Troweling in the Belzona 4111 ,
- \* A coat of Belzona 4311 brushed over the drain surface ,

Damaged concrete in kitchen drain.

The application was carried out in accordance with Belzona Know-How System Leaflet FPA-3. The concrete was cleaned and the steel was ground. Belzona 4111 was troweled over the area. A coat of Belzona 4311 was brushed over the surface, including the steel drain, to protect from chemical attack.
