BELZONA IMPROVES SAFETY WITH NONSKID SURFACE

ID: 5263

Application: FPA-Floor Problem Areas

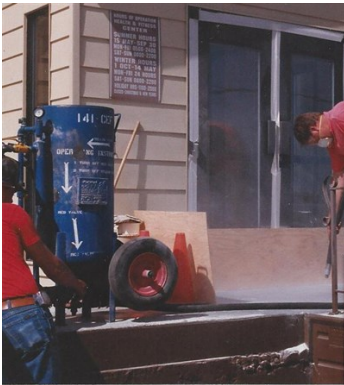
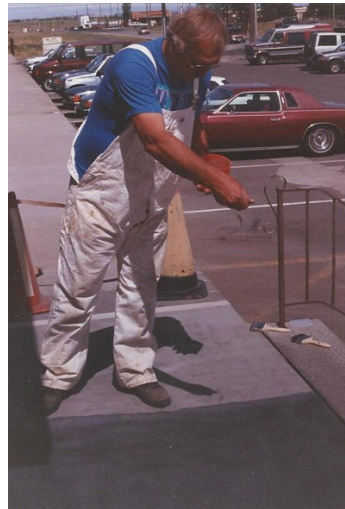
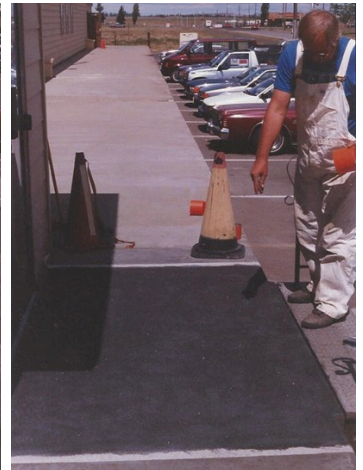
Photograph Descriptions

Ice build-up on the steps was causing slip problems. The chemical deicer was destroying the concrete.

- * Blasting the concrete ,
- * Brushing on Belzona 4411 ,
- * Sprinkling on Belzona 9221 ,
- * Completed application ,

Application was carried out in accordance with Belzona Know-How System Leaflet FPA-8. The surface was blasted to remove all surface laitence. Belzona 4411 was brushed onto the surface and Belzona 9221 was spread on top.
