BELZONA IMPROVES SAFETY WITH NONSKID SURFACE

ID: 5263

Application: FPA-Floor Problem Areas

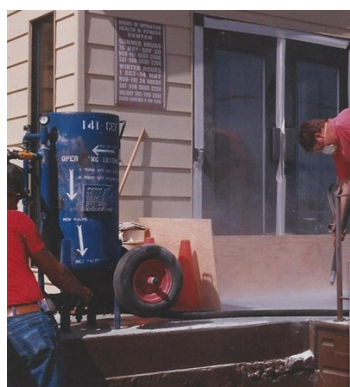
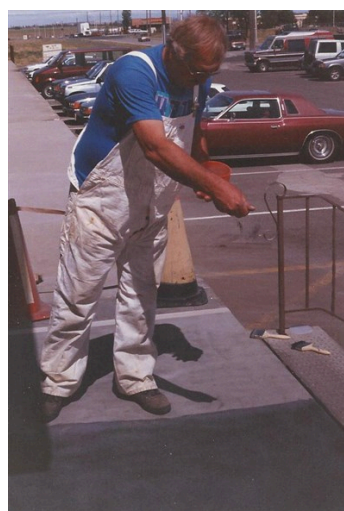
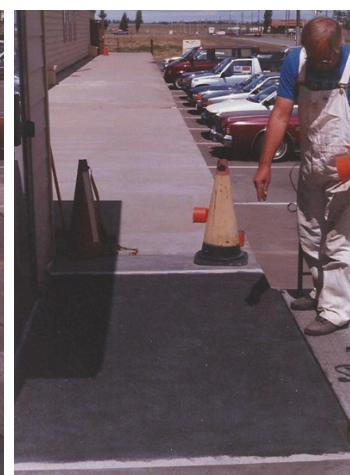
Photograph Descriptions

Ice build-up on the steps was causing slip problems. The chemical deicer was destroying the concrete.

- * Blasting the concrete ,
- * Brushing on Belzona 4411 ,
- * Sprinkling on Belzona 9221 ,
- * Completed application ,

Application was carried out in accordance with Belzona Know-How System Leaflet FPA-8. The surface was blasted to remove all surface laitence. Belzona 4411 was brushed onto the surface and Belzona 9221 was spread on top.

The nonskid surface remained perfect until the building was demolished over 20 years later.
