# BELZONA AVOIDS COSTLY DOWNTIME BY PATCHING FUEL BLADDERS

ID: 5265

Application: *SHM-Solids Handling Machinery*

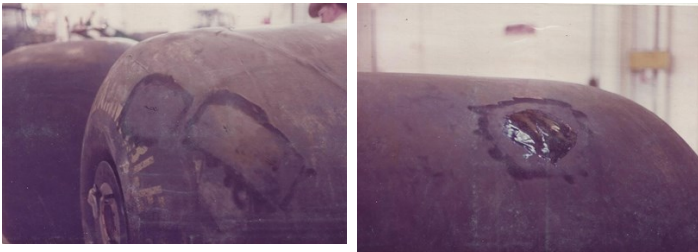
*Scrapes on the outer rubber layer of the large towable fuel bladders would allow water to wick into the fabric, weakening the fuel bladder.*

- \* Bladder showing damage and prepared for conditioner ,
- \* Completed application ,

Application was carried out in accordance with Belzona Know-How System Leaflet SHM-9. The surface was roughened and Belzona 2911 was applied and allowed to cure. Belzona 2221 was brushed on and Belzona 9341 was stippled in. Two hours later a final coat was brushed over the surface.
