# BELZONA IMPROVES SAFETY WITH GRIP SYSTEM ON STEPS

Application: FPA-Floor Problem Areas

Nonslip on football stadium steps.

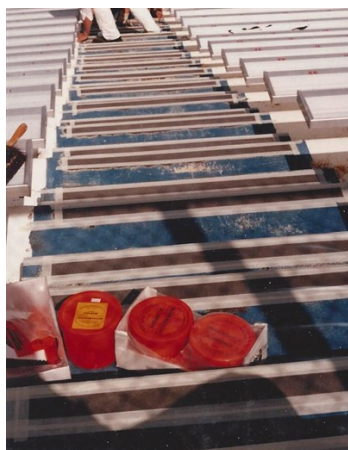
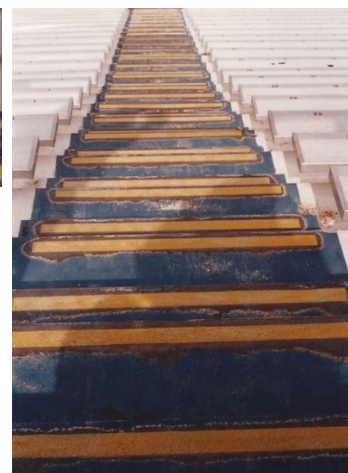
Stick on strips had caused tripping problems.

- \* Overview of football stadium ,
- \* Nosings blasted and masked off ,
- \* Brushing on Belzona 4411 ,
- \* Completed application, ready for repainting ,

The application was carried out in accordance with Belzona Know-How System Leaflet FPA-8. The step nosings were blasted. The nosings were masked off and Belzona 4411 was brushed on. Belzona 9221 was sprinkled on.

Stick on strips had proved to be ineffective, causing trip hazards. Belzona 4411 reduced the potential for accidents and provided an aesthetically pleasing finish.
