BELZONA PROVIDES EMERGENCY REPAIR ON A WORN CONVEYOR BELT

ID: 5277

Application: SHM-Solids Handling Machinery

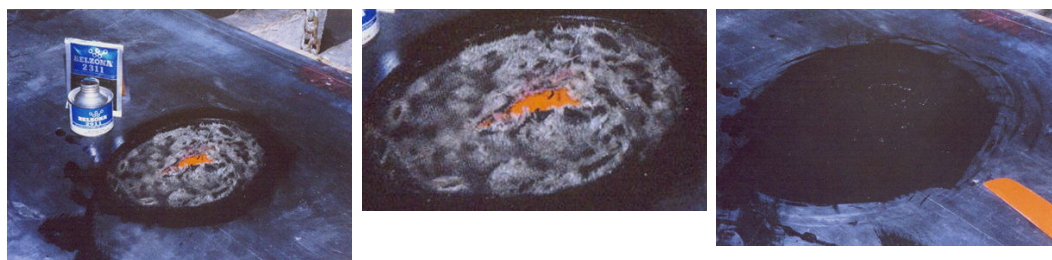
A large hole had formed in this conveyor belt, causing an interruption in production.

- * Damaged conveyor belt, ready for repair. ,
- * Close up of repair area showing the use of the Belzona mixing surface, which was positioned underneath the belt to act as a suitable temporary backing for the repair. ,
- * Completed application. ,

The application was carried out in accordance with Belzona Know-How System Leaflet SHM-1.

A large hole on the conveyor belt threatened to interrupt production. The use of Belzona 2311 enabled maintenance and completed the necessary repair. Belzona reinforced the conveyor belt with a minimum amount of downtime and also prevented the loss of production.
