# BELZONA PROTECTS MIXER BLADES FROM ABRASION

ID: 5279

Customer Location: Lawrence, KS, USA

Application Date: September 2007

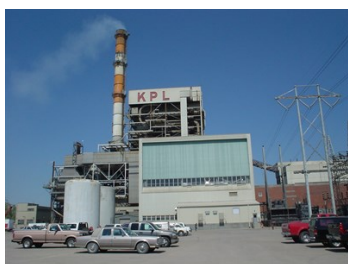
The mixer blades in this crystalization tank exhibited serious damage due to abrasion. This is a very important component in the Flue Gas Desulfurization system.

- \* View of the plant ,
- \* Close-up view of the damaged mixer blades ,
- \* Preparing the surface of the blades prior to application ,
- \* Completed application ,

The Belzona trained contractor mechanically prepared each blade prior to rebuilding to the original contour with Belzona 2111. Then, the blade circumferences were further protected with multiple coats of Belzona 2131.
